Inspection Report

Dave Sfreddo Home Inspection Services llc

3119 Taylorsville Road Culpeper, Virginia 22923

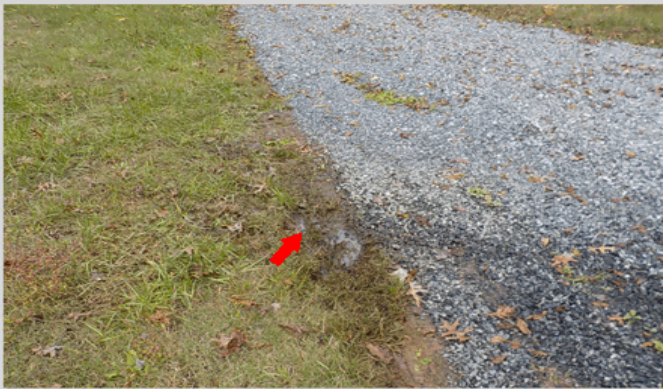
1) Grading Conditions

Evidence of water ponding / collection was observed at front yard and driveway . Whenever ponding is observed, particularly near the foundation, some concern about the lot drainage may be warranted. It is beyond the scope of our inspection to verify drainage systems.

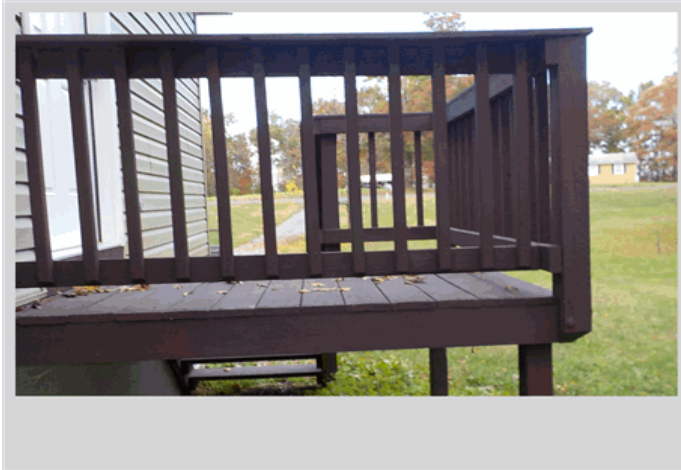
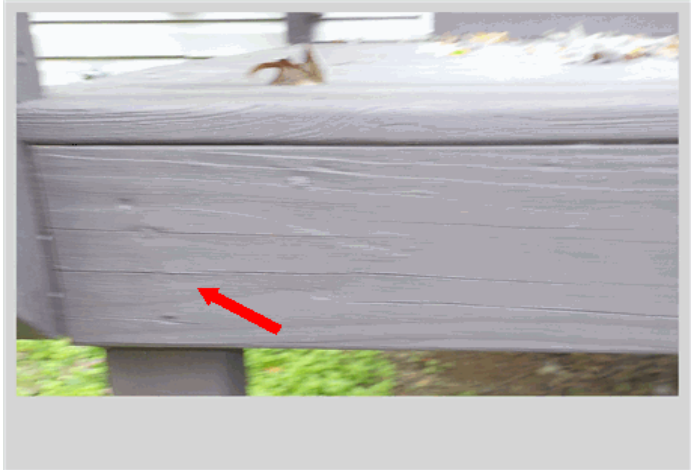
5) Deck Conditions

Bolts are recommend at deck and post connections.

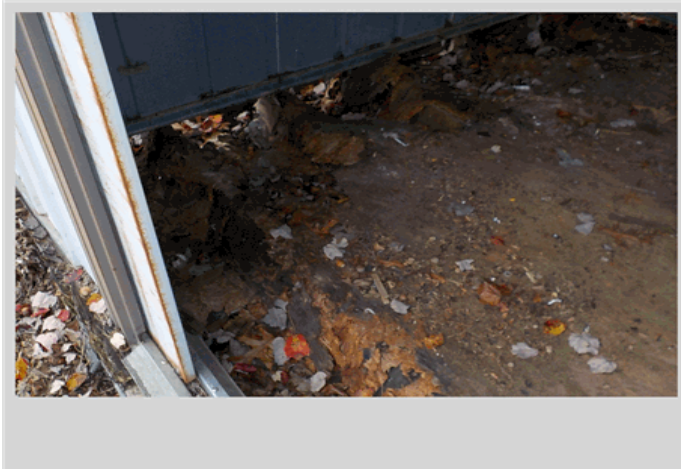
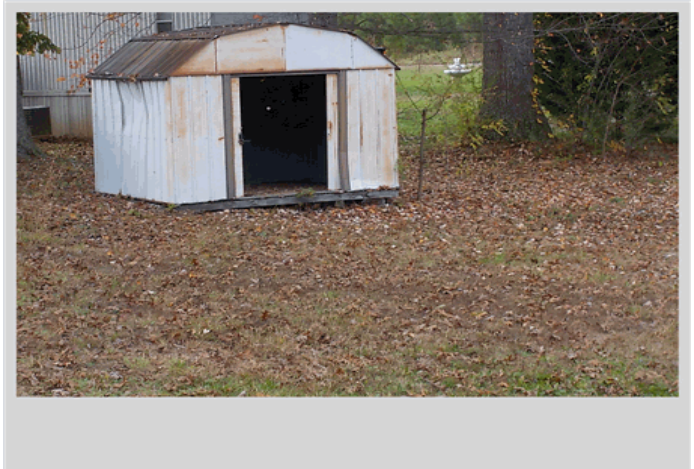
6) Shed Conditions

The sheds floor is rot damaged.recommend replacing the shed floor.The shed is older and deteriorated.

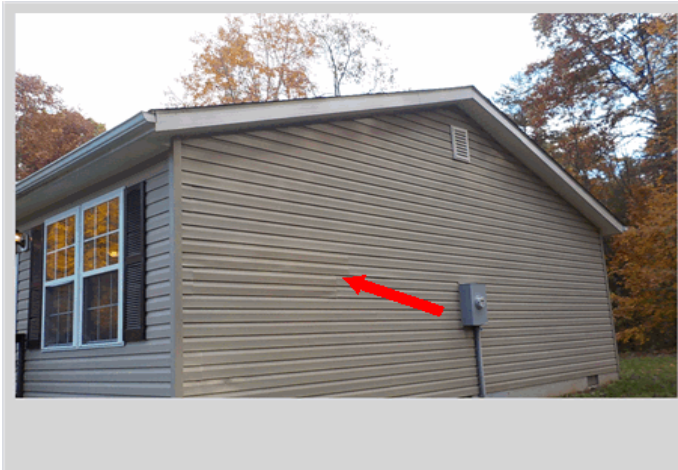
9) Exterior Wall Conditions

Previous repairs have been made to the siding.

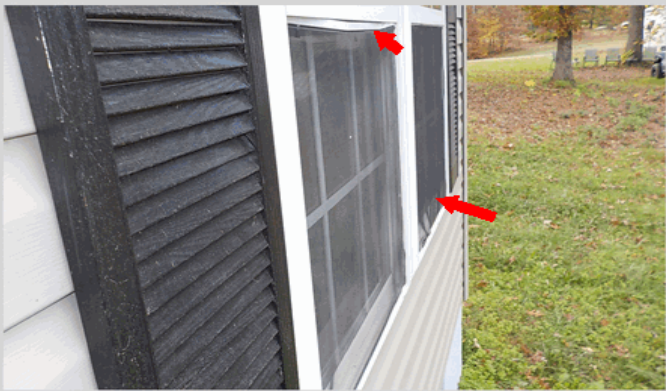
10) Window Conditions

Damaged window screens at front windows. Recommend repairs/replacements.

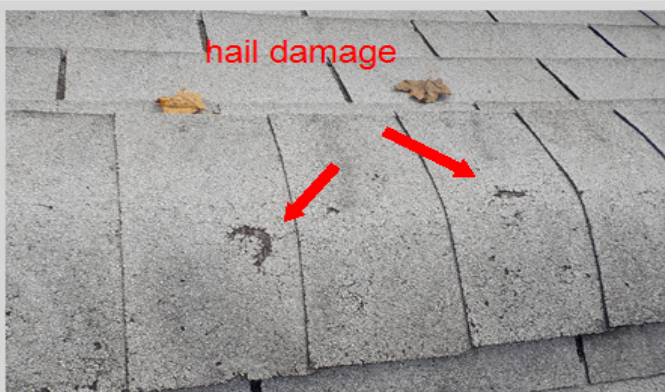
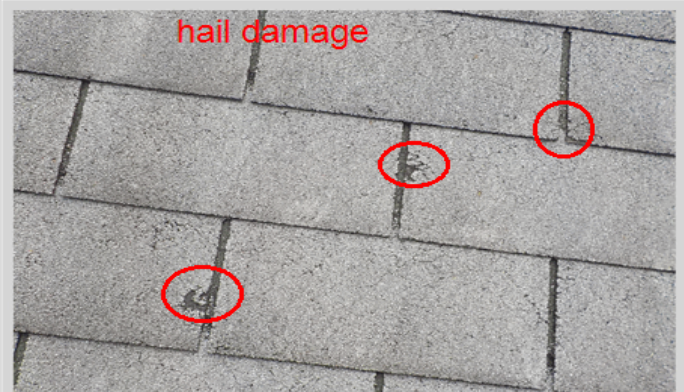
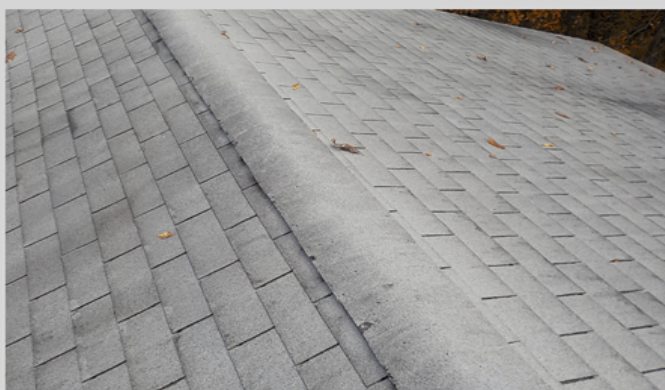
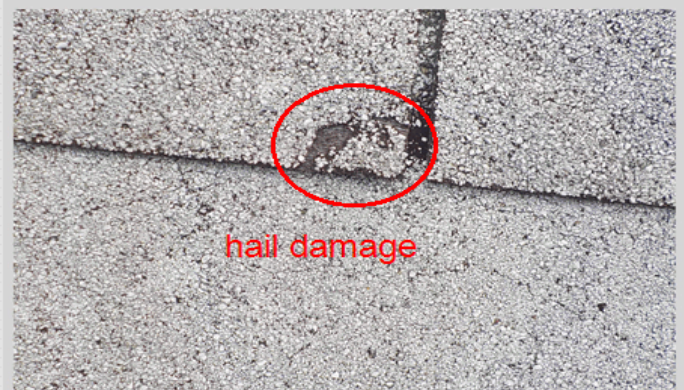
13) Roof Covering Condition**AS**

There were no leaks at time of inspection. Aggregate disturbance on roof shingles is consistent with that of Hail Damage. It is suggested that a "Licensed Roofing Contractor" be contacted for further evaluation. Algae stains sighted on roof. Algae can be removed with appropriate chemicals. Recommend contacting a roofer for service.

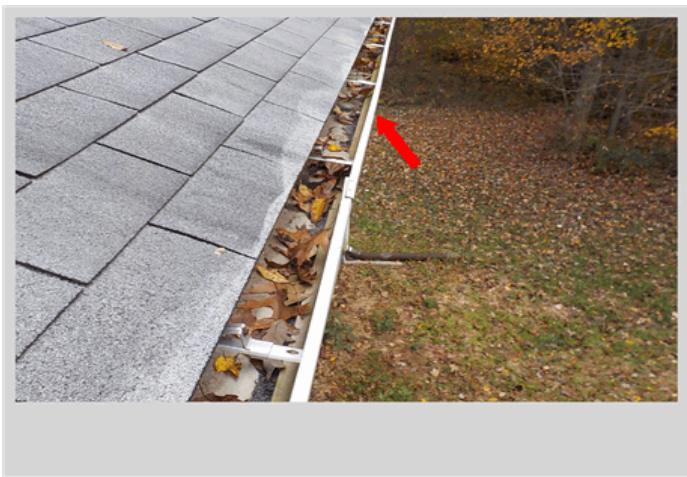
15) Gutter & Downspout Conditions

The gutters were filled with leaves and debris at the time of the inspection. Suggest cleaning and removal of debris on a regular basis. This condition can cause water penetration at the eave area. Gutter guards are recommended.

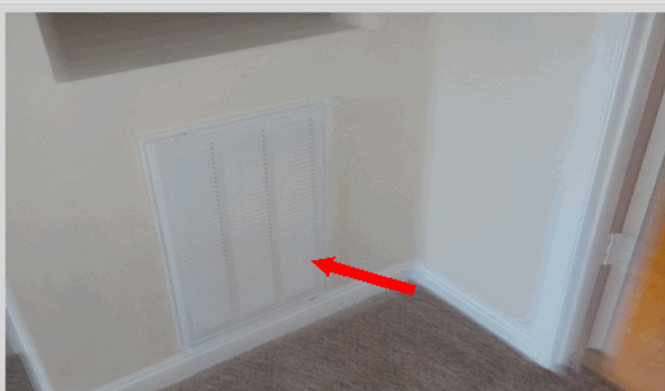
19) Distribution Conditions

The air filter is dirty.Recommend changing the air filter.

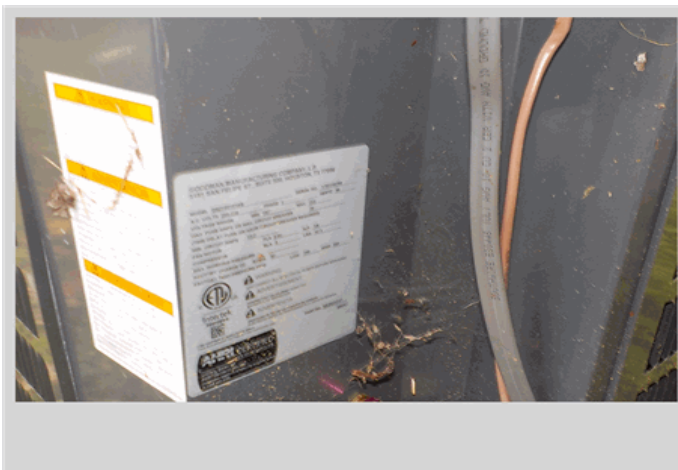
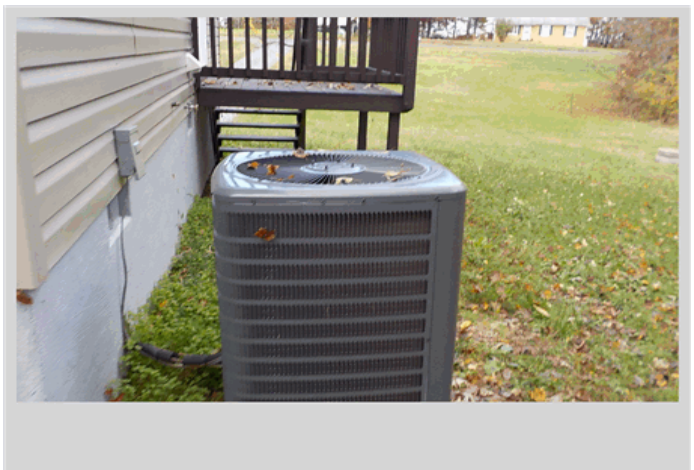
21) AC Unit Conditions**AS**

All HVAC systems should be serviced and cleaned yearly by an HVAC company. The temperature difference between the supply and return air of the cooling system should be a minimum of 16 degrees. The temperature split was 27 degrees. The AC system operated at time of inspection. NOTE: the HVAC system is new, it is recommended that the client obtain all warranty paperwork.

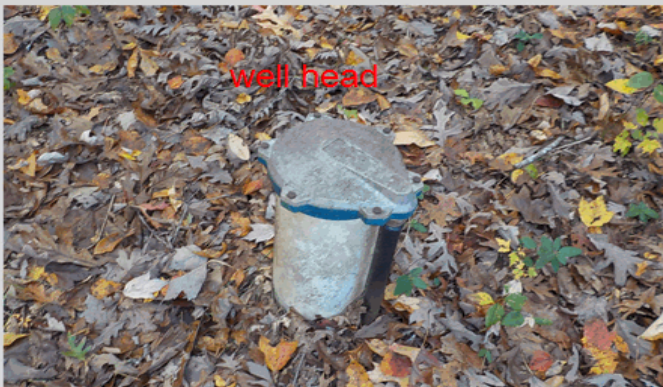
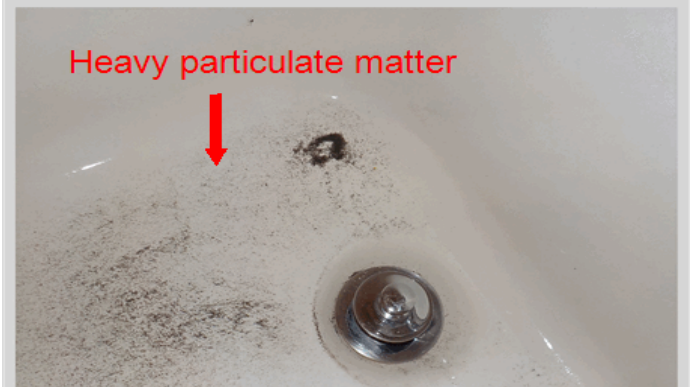
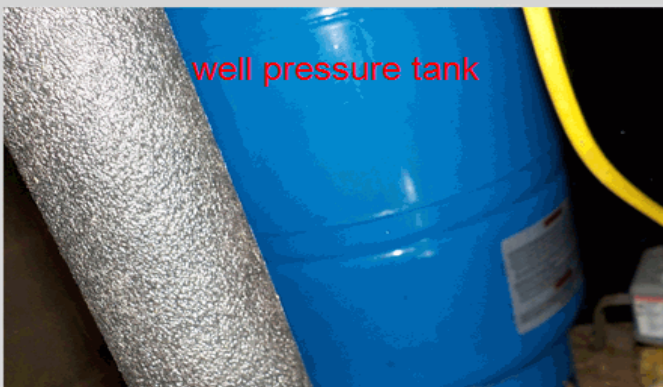
26) Main Line & Valve Conditions**R**

Continual Water pressure fluctuations were observed during the inspection. Particulate matter was observed in water supply. These condition indicate a well system problem. It is recommended that a qualified well company evaluate the system and perform any needed repairs. The water supply has a sulfur odor. Recommend an evaluation by a water treatment company. The domestic water appears to be supplied by a private well system. Sub-surface or concealed components are outside the scope of this inspection. A well and water test are advised.

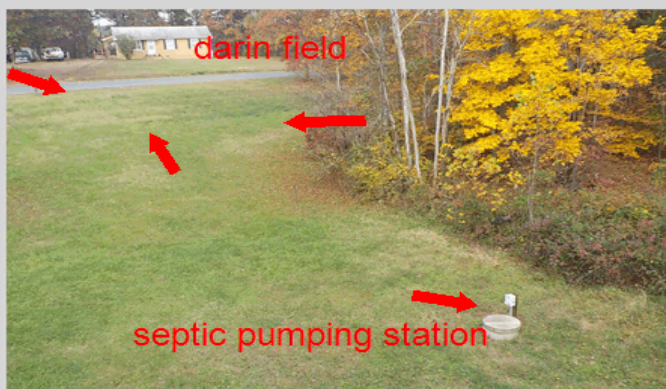
28) Drain Line Conditions

A septic system is present at the property. Septic system testing and evaluation are outside the scope of this inspection. Client is advised to consult with a licensed plumber or licensed septic certification specialist for evaluation and testing prior to close.

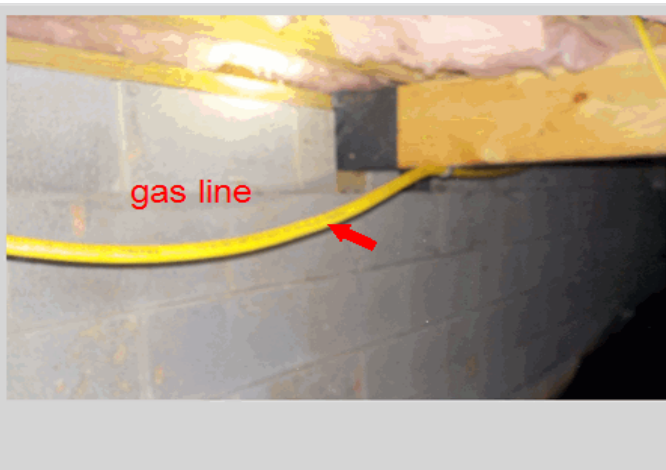
31) Gas Line Conditions

There is csst gas pipe in crawl space but there is no propane gas supply to the house.

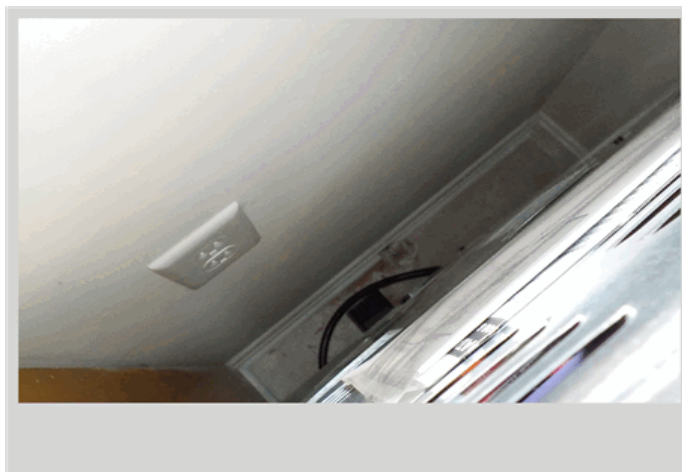
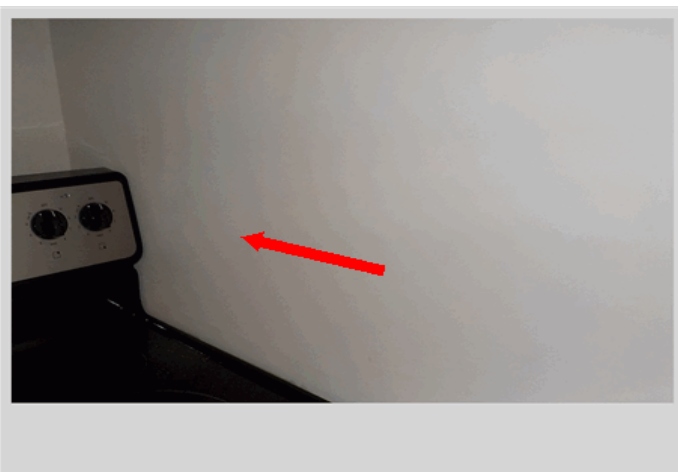
50) Stove - Range Condition

No anti-tip device at stove. Recommend installing an anti tip device. A heat shield should be considered at drywall adjacent to the stove/oven to protect drywall against heat damage and possible fire.

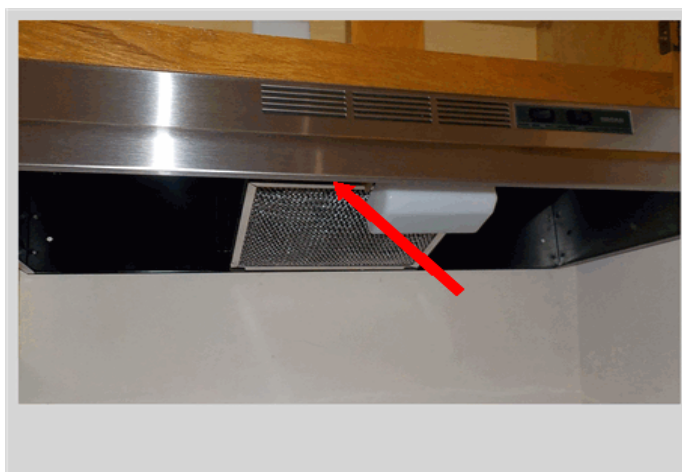
51) Hood Fan Conditions

The hood is not operating or connected and is loose at cabinet. Recommend repairs by a qualified company.

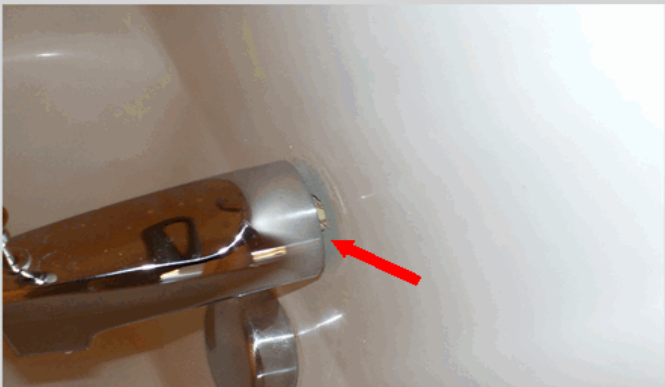
64) Shower - Tub Conditions

The tub faucet is loose at wall.

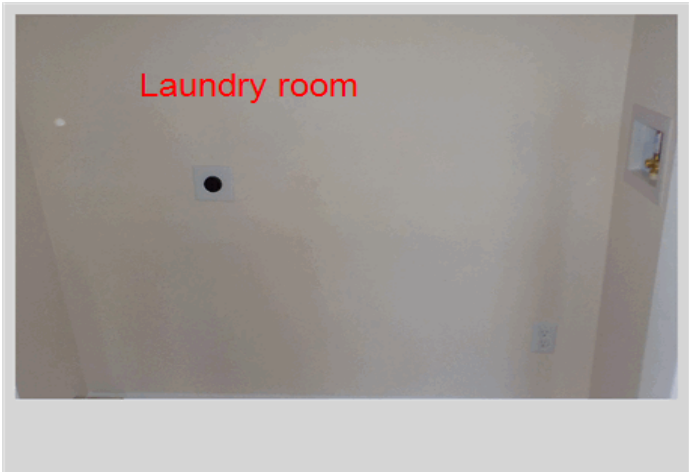
66) Laundry Room Conditions

There were no appliances present for proper testing of plumbing components.

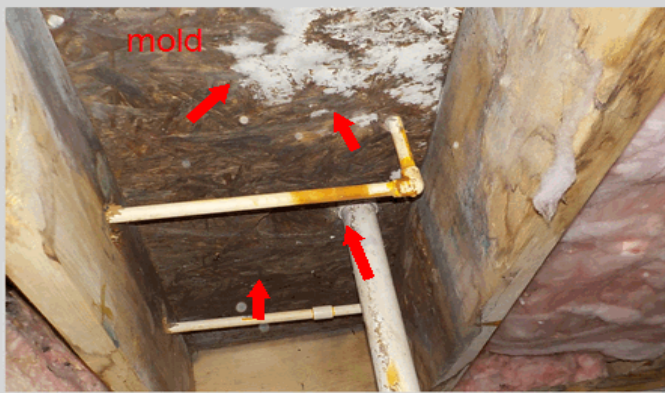
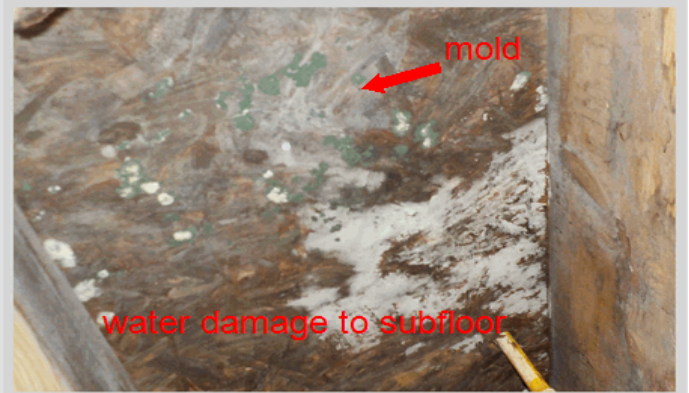
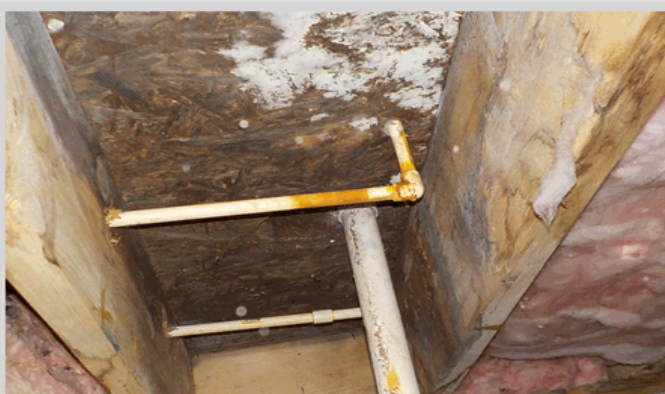
Mold was sighted on sub-flooring under the bathtub, viewed from crawlspace. Rot damage was sighted at the sub-floor under the tub. recommend an evaluation by a mold remediation company. A general contractor should evaluate the rot area and locate the source of leaks and perform any repairs needed. NOTE: the leak is related to the tub but the exact source could not be determined.
